# Manhole Inspection Summary

Manhole # S29EE1013MH

Insp Date: **12/15/06 11:46 AM**

**Location** Address: **611 39TH ST**

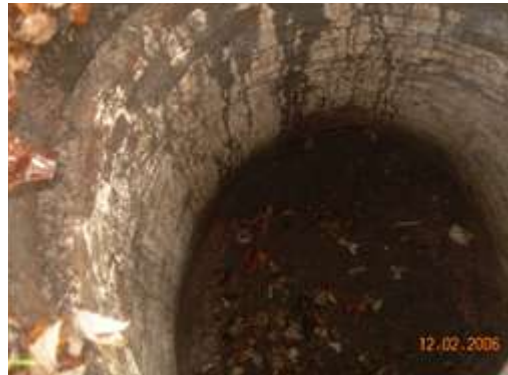
Top View

**Frame** Offset: **1** (in.)

☒ **Debris** (not Condition related)

Frame offset. Channel debris.

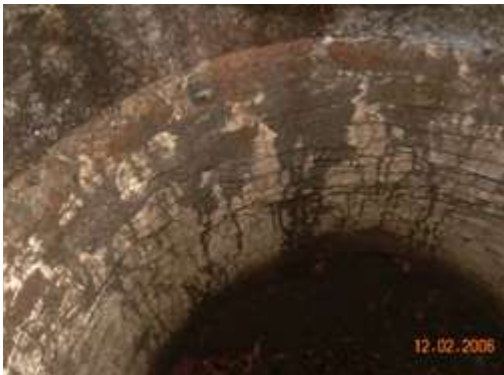
Defect

☒ **Leaks**

Infiltration: ☐ None ☒ **Joint** ☐ Cracks ☐ Mortar ☐ Roots ☐ Wall

Infiltration: ☐ None ☐ Joint ☐ Cracks ☒ **Mortar** ☐ Roots ☒ **Wall**

Frame leaks. Adjustment and Barrel infiltration.

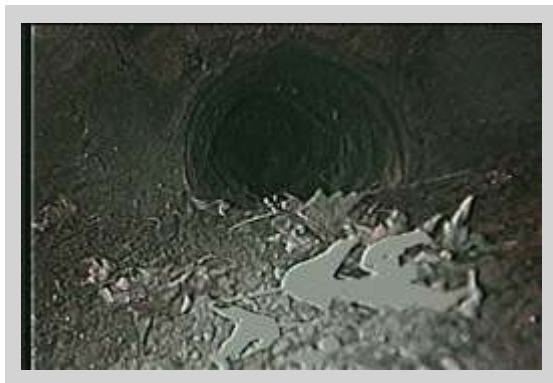
8 in. Circular Gravity Sewer

Pipe Out @ 12 O'Clock

Deposits: ☐ None ☒ **Mud** ☐ Sludge ☒ **Debris** ☐ Grease

Silt Depth: **1** (in.)

Infiltration: **Evidence**
